**FINAL SITE MANAGEMENT PLAN FISCAL YEARS 2008 THROUGH 2012  
PETROLEUM, OIL AND LUBICANT SITES NAS OCEANA VA**

# **Site Management Plan Fiscal Year 2008-2012**

## **Petroleum, Oil, and Lubricant Sites**

**December 2008**

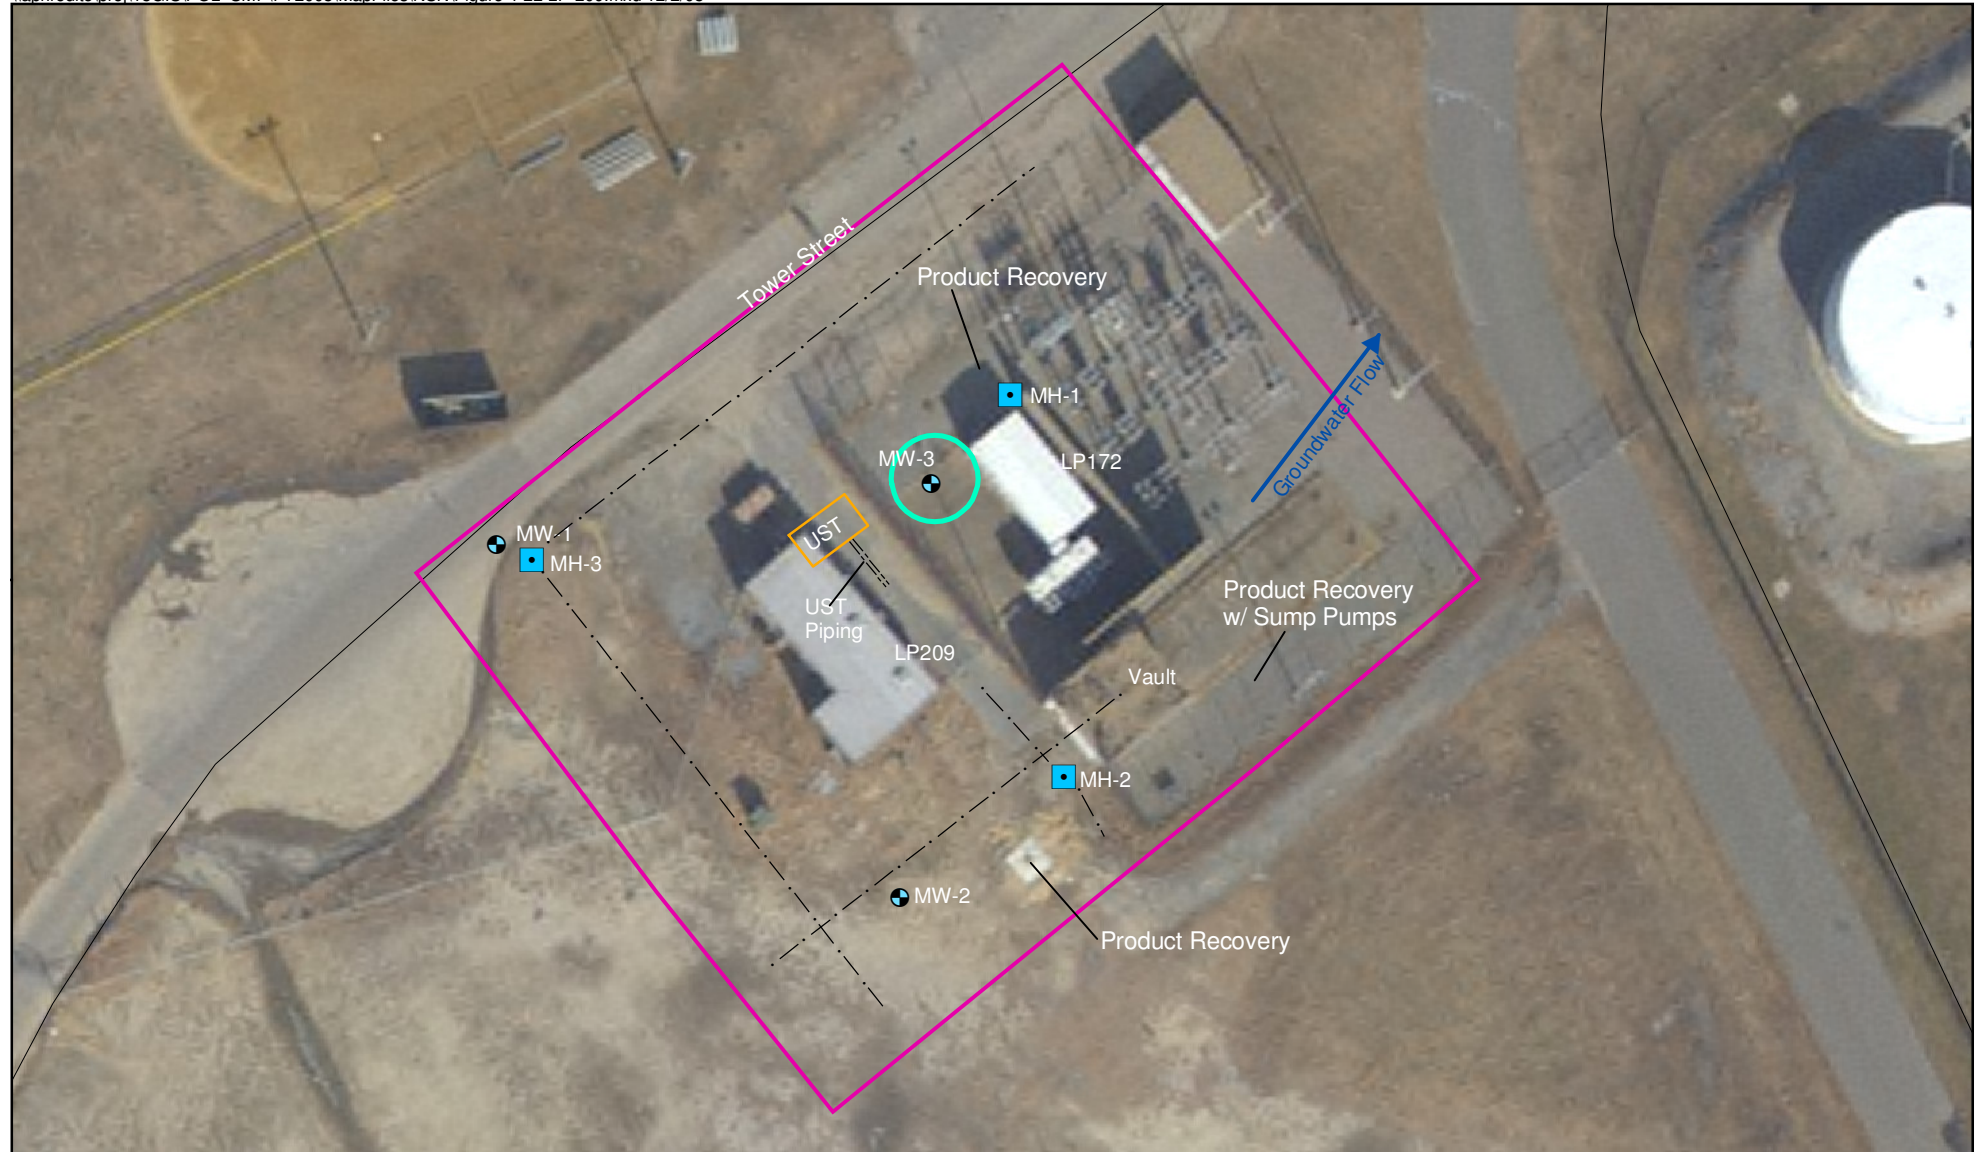
- Monitoring Well
- Free Product Plume (March 2008)
- Site Boundary
- Manhole
- Utility Conduit

Lithology at the LP-209 sites consists of sandy soils with some clay. Hydraulic conductivity at the site is approximately  $10^{-2}$  cm/s, based on the soil type. Free product is currently present in one well at a thickness of 0.01 ft. Recovery during the first quarter of 2008 consisted of 0.1 gallon of product. Additional physical recovery is not likely at this site. Addition of nitrate or an oxygen source such as ORC<sup>®</sup> is recommended to facilitate biodegradation of the contaminants. Costs associated with such a treatment are between \$15,000 and \$20,000

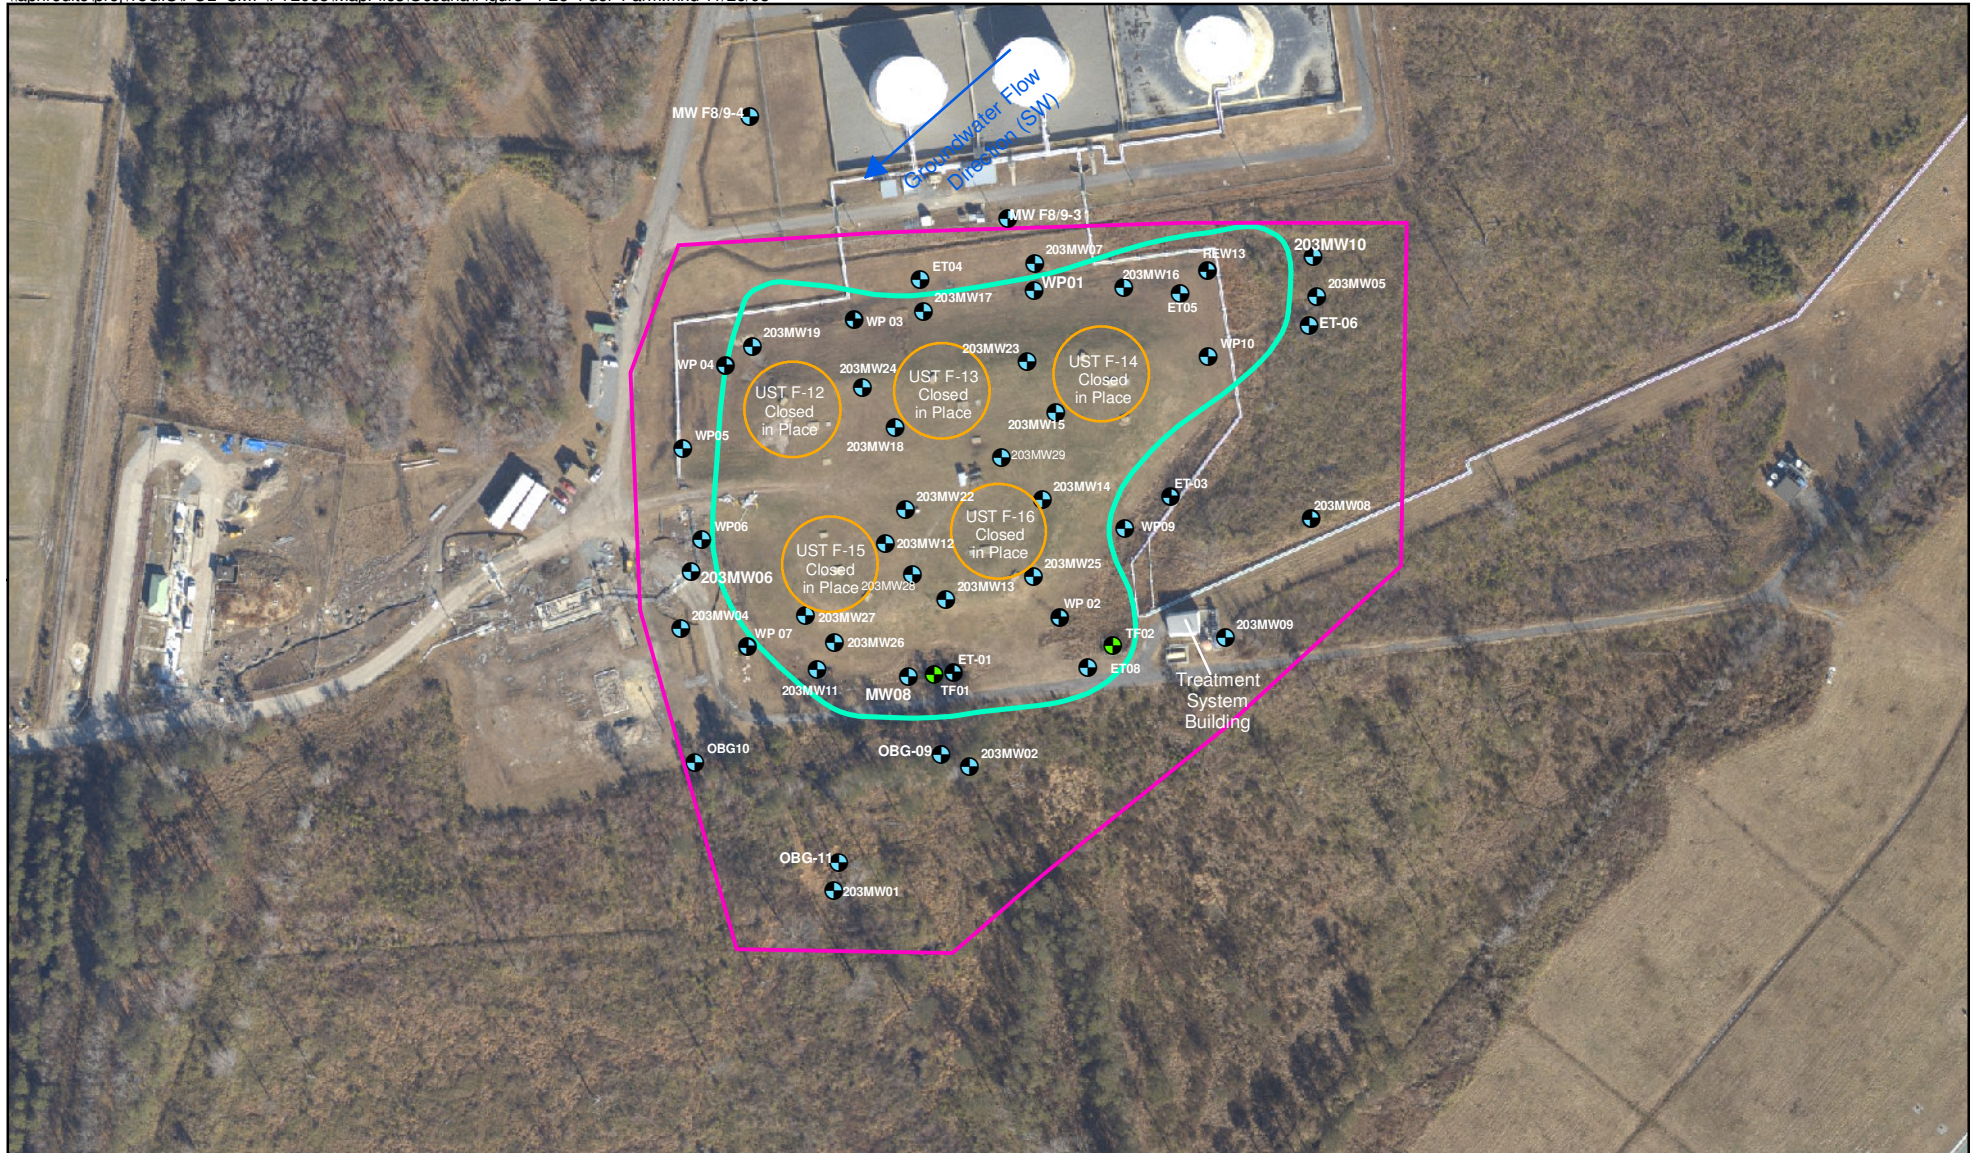
- Site Boundary
- Monitoring Well
- Recovery Well
- Free Product Plume (March 2008)

Hydraulic conductivity at the site is approximately  $10^{-3}$  cm/s. Free product recovery is completed using skimming and AFVR. Measurable free product has been detected in 21 wells at thicknesses up to 11 ft. Between 300 and 800 gallons of fuel per quarter are being recovered using these methods. Recovery efforts should continue as long as significant LNAPL volume (i.e., at least 10-20 gallons per month) is maintained. Once free product recovery is no longer resulting in removal of substantial amounts of product, installation of in well aeration systems is recommended to encourage in situ biological degradation.

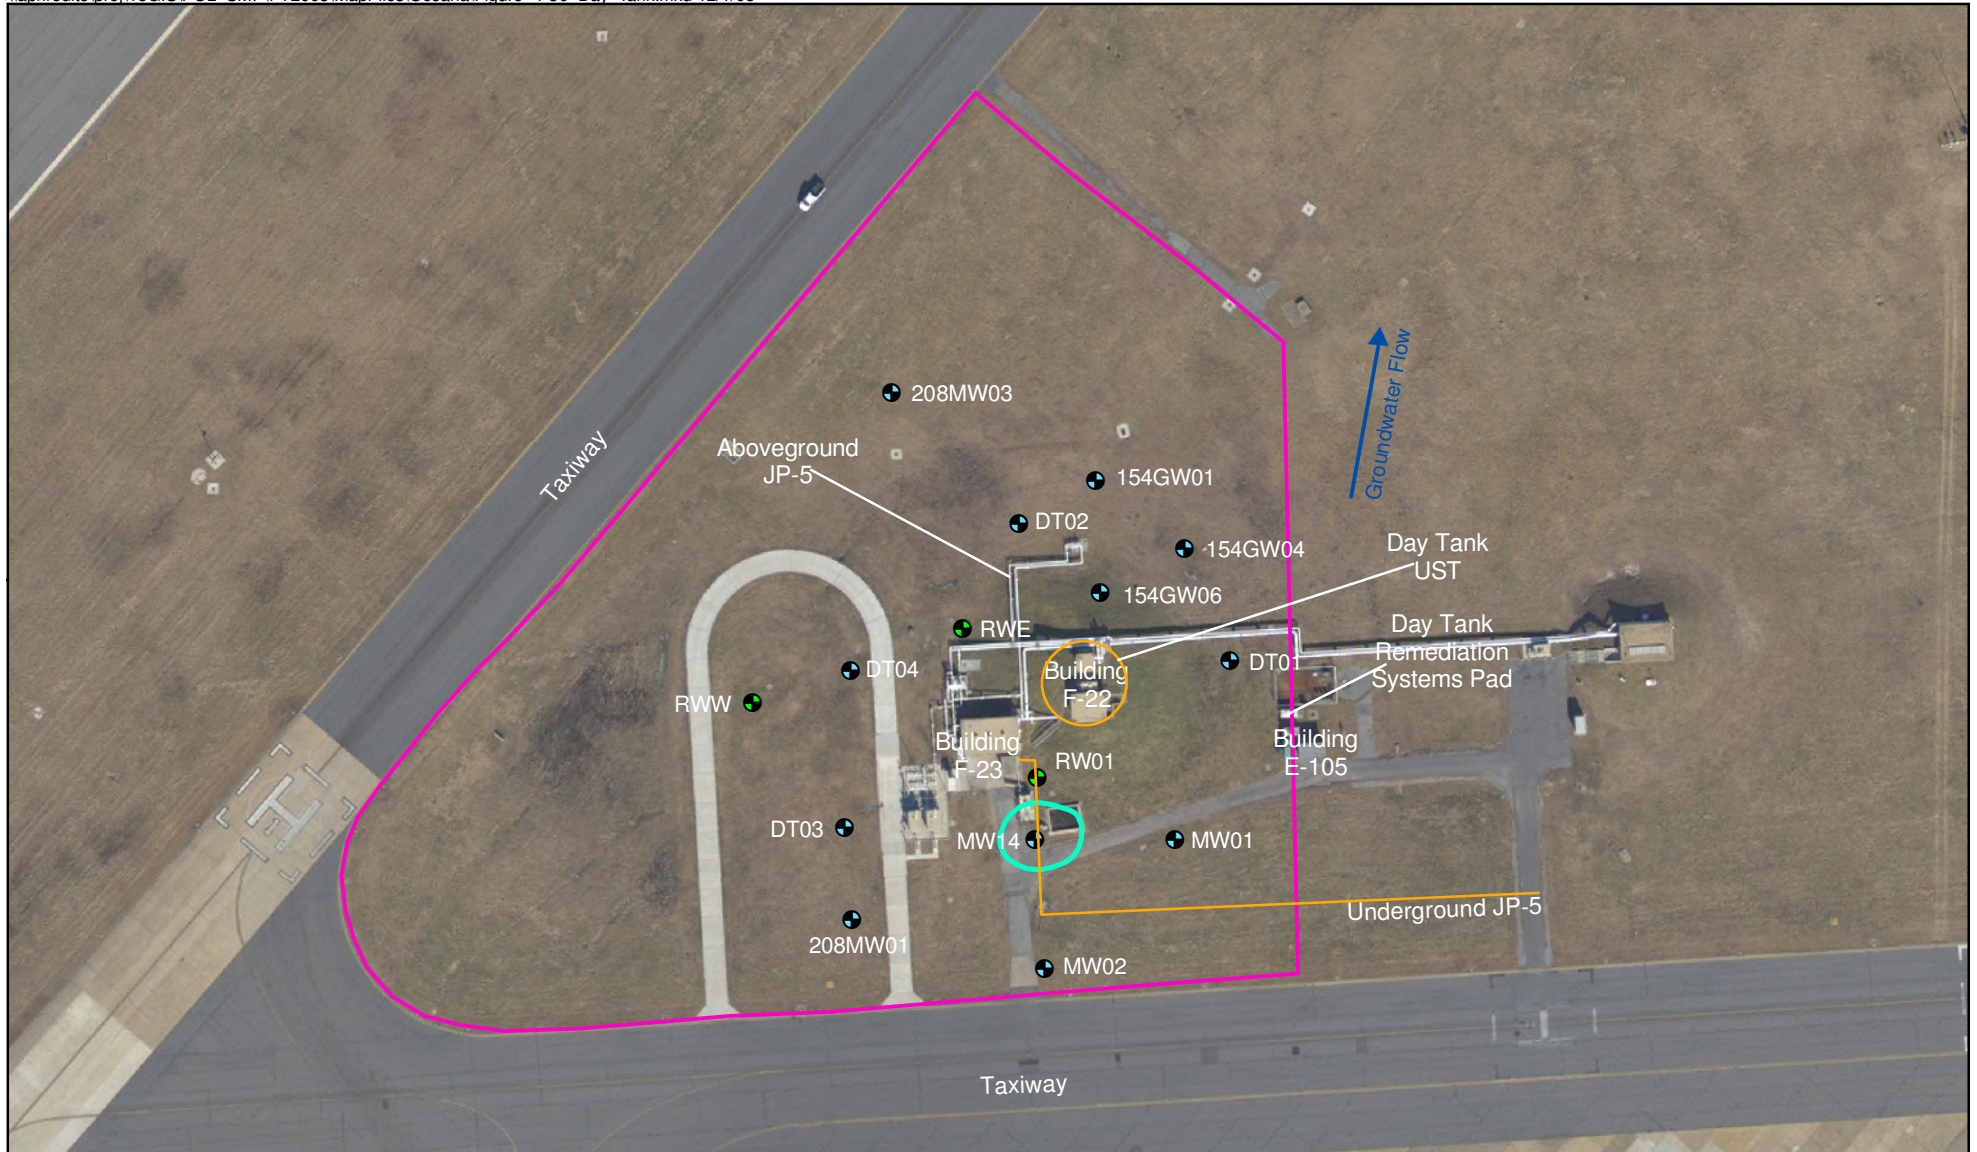
- Monitoring Well
- Recovery Well
- Site Boundary
- Free Product Plume (March 2008)

Due to the close vicinity and similar site characteristics of the MATWING and Day Tank sites, the recommendations for optimization of product removal were evaluated simultaneously. Lithology at the MATWING and Day Tank sites consists of clay, silt and fine sand. Hydraulic conductivity at the sites is approximately  $10^{-3}$  cm/s. Free product recovery is conducted with manual bailing, skimmers, and AFVR events. The maximum free product thickness at the sites is 0.02 ft. Approximately 1 gallon of product is currently being recovered each quarter. Product remaining at these sites appears to be residual in nature and is unlikely to be recovered in significant quantities using physical recovery methods. Nitrate enhancement or addition of oxygen via installation of an air sparging system or injection of ORC® should be considered to facilitate biodegradation. Costs associated with nitrate amendments are estimated to be \$50,000 per year. Costs associated with installation of a biosparging system are between \$500,000 and \$1,000,000.

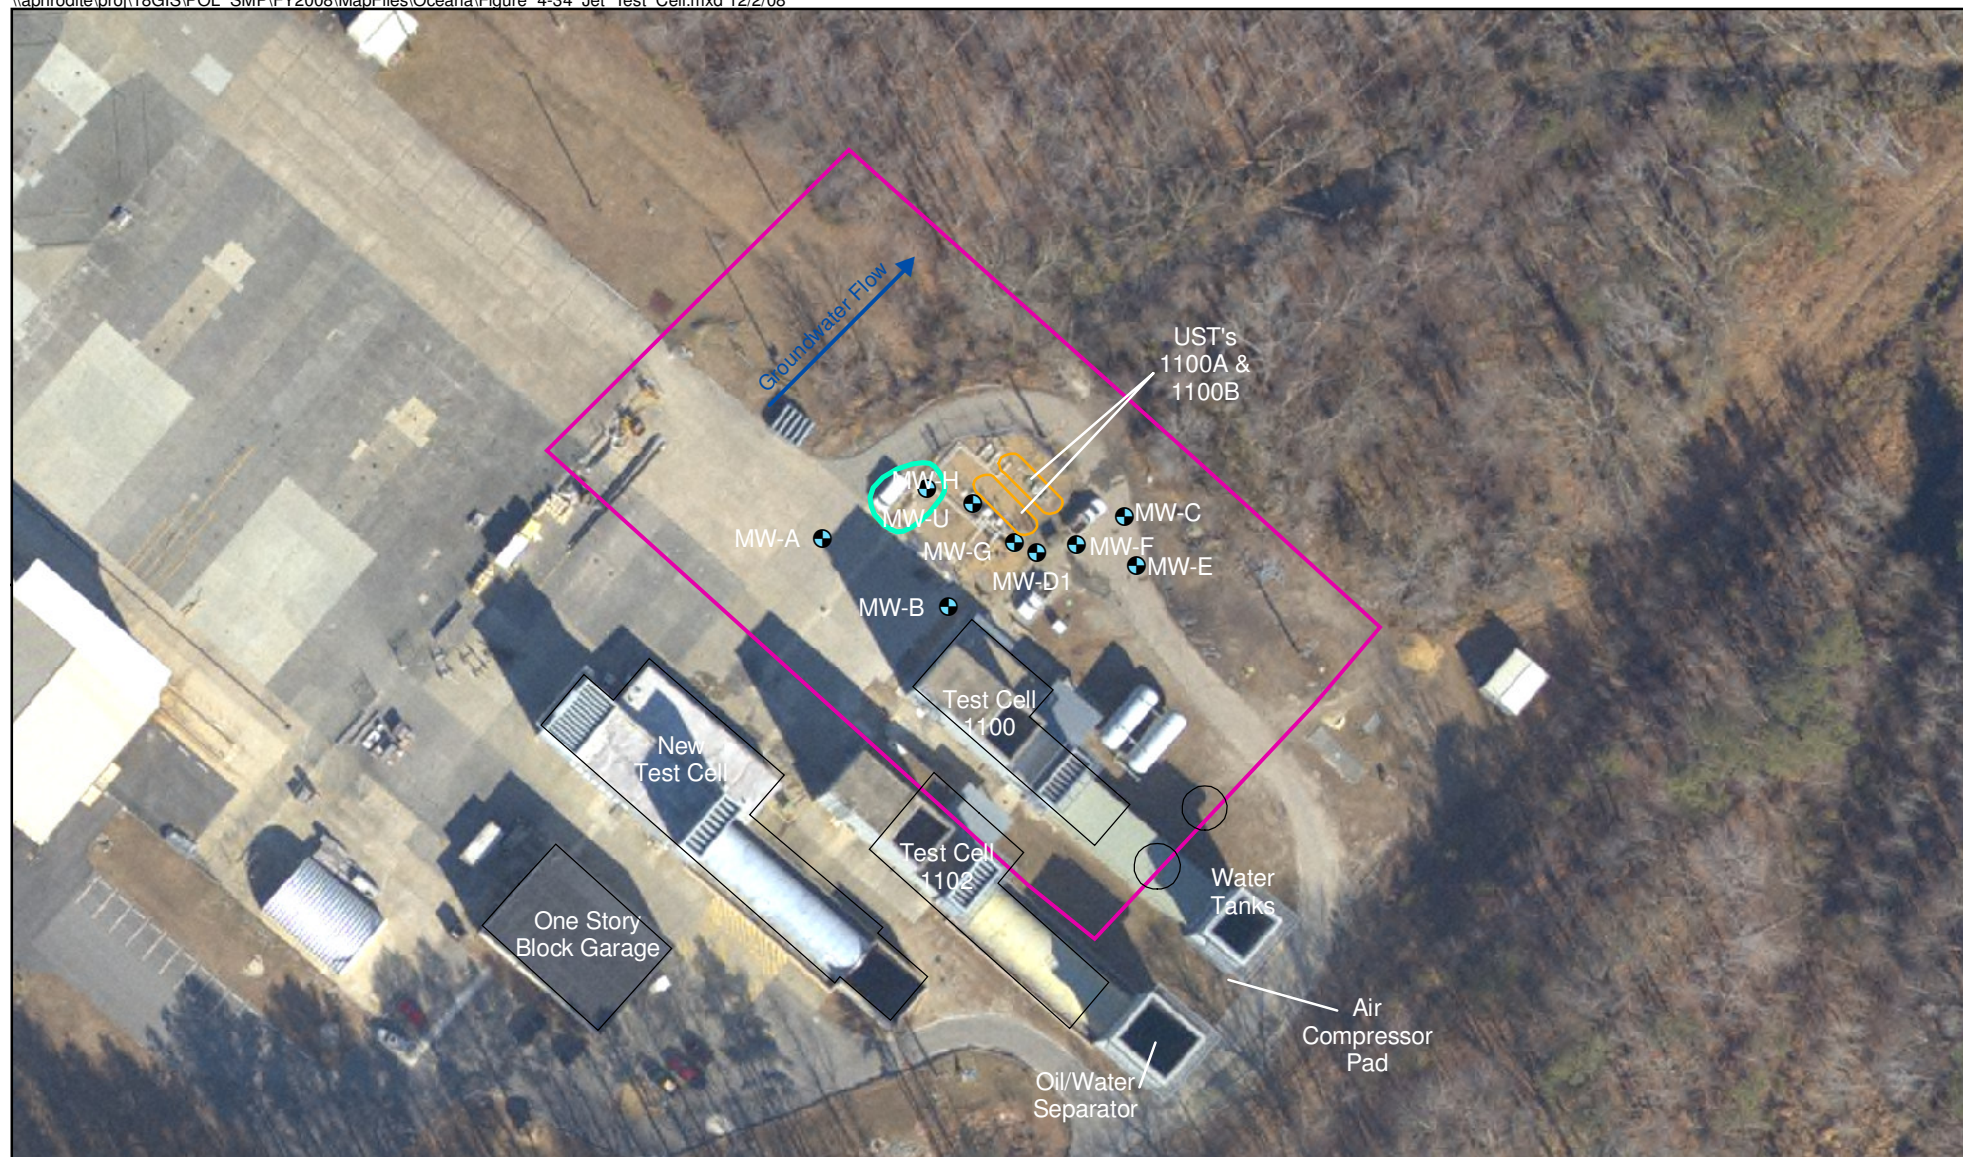
- Monitoring Well
- Free Product Plume (March 2008)
- Site Boundary

Lithology in the vicinity of the Jest Test Cell consists of silty sand and gravel. Hydraulic conductivity based on the soil type is estimated to be  $10^{-1}$  cm/s. Product recovery is conducted using manual bailing and averages less than one gallon per quarter. Free product is present on the water table in one well location at a thickness of 0.01 ft. The thickness of product had decreased considerably since 2007 when 0.68 ft of product was measured in the same well. Product monitoring should continue to determine if the endpoint can be met without additional action. If free product thickness does not decline, it is recommended that an oxygen source such as RegenOx, ORC®, or BIOX® be injected to chemically destroy and/or biologically degrade the product. Costs associated with these recommended treatments are estimated to be between \$20,000 and \$25,000.

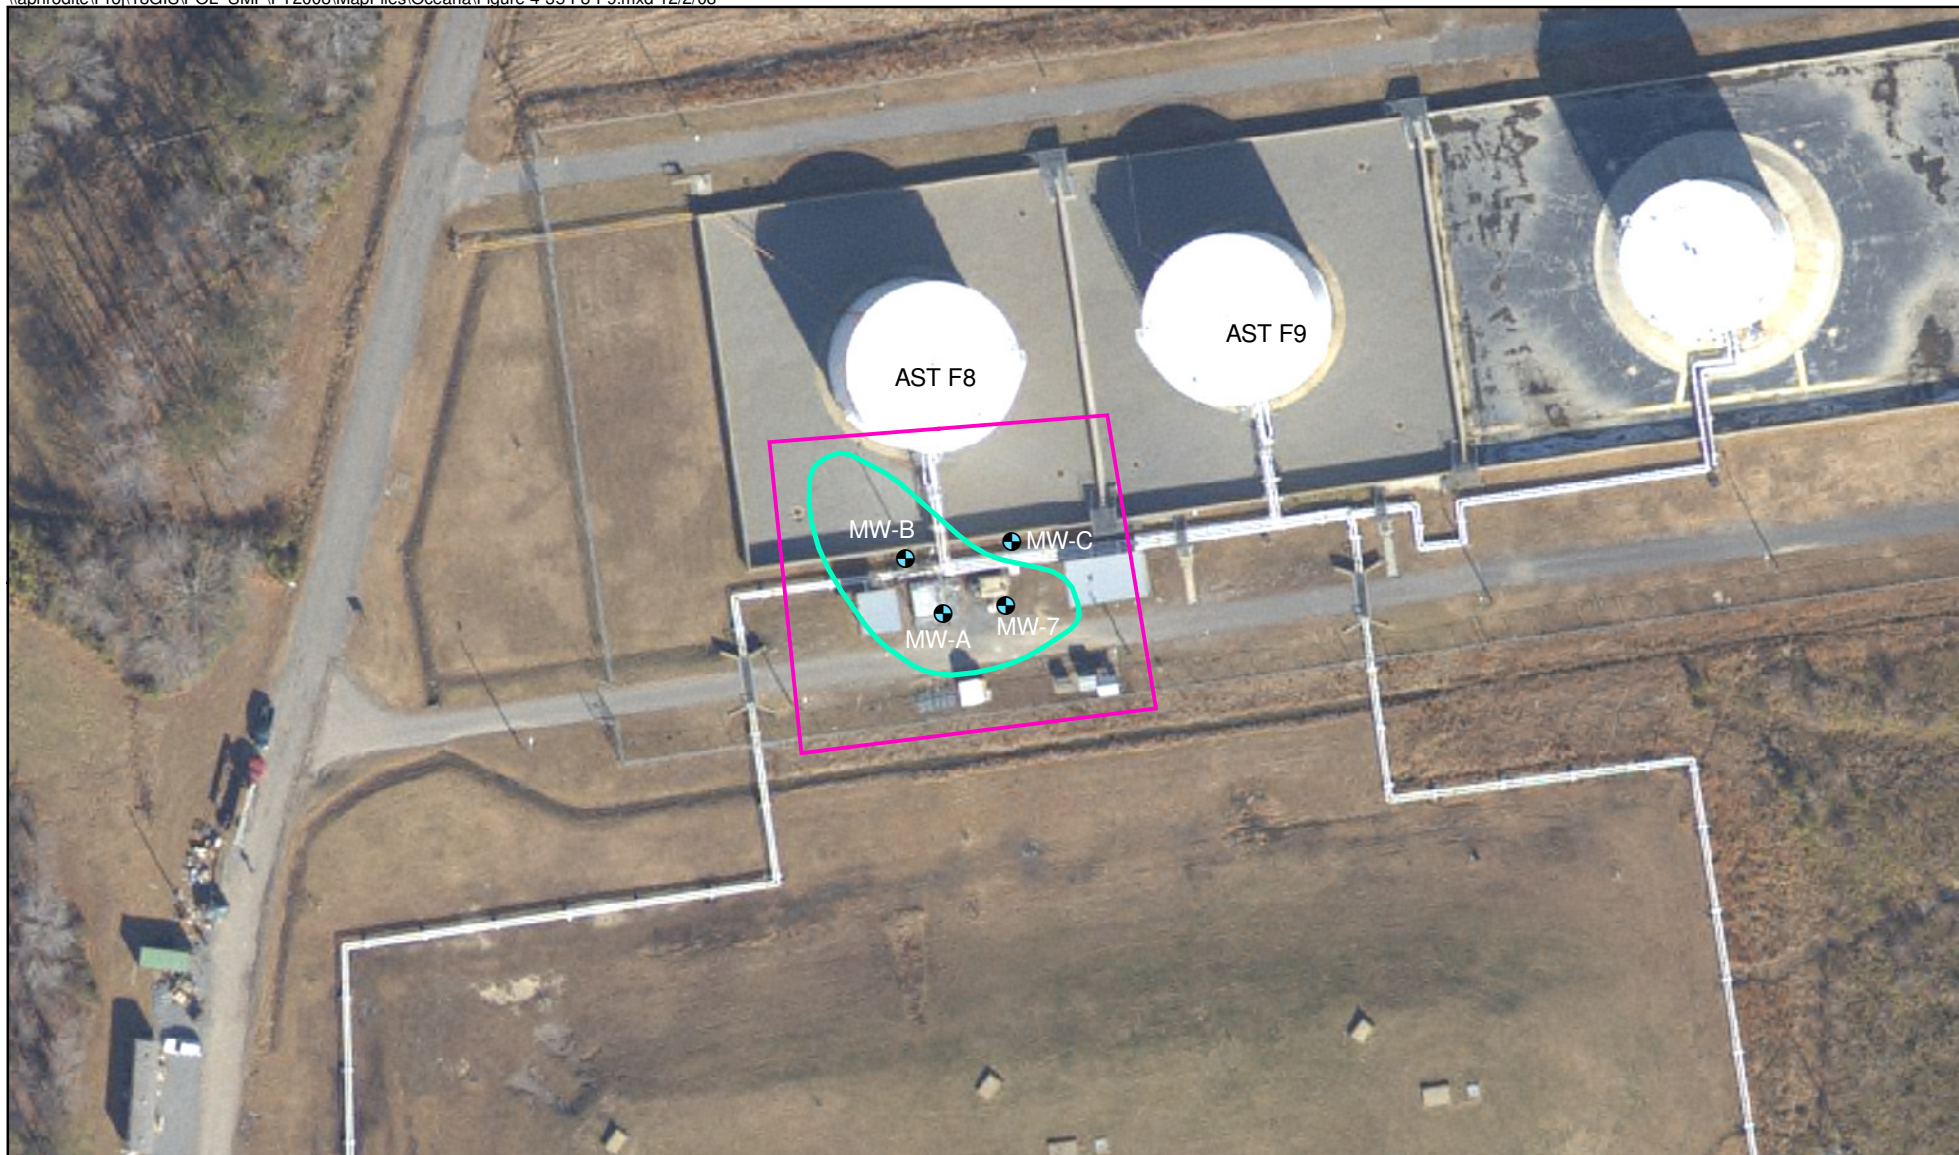
- Monitoring Well
- Free Product Plume (March 2008)
- Site Boundary

Lithology at the F8/F9 site consists of silty sand with some clay lenses. Hydraulic conductivity at the site is approximately  $10^{-4}$  cm/s. Product recovery is conducted using manual bailing and averages around 5 gallons per quarter. Free product is present on the water table at three locations at thicknesses of up to 0.21 ft. However, product thickness has decreased considerably since 2007 when 0.87 ft of product was measured. Product monitoring should continue to determine if the endpoint can be met without additional action. If free product thickness does not decline, it is recommended that an oxygen source
